CASE STUDY: ECMC – KIDNEY CARE

WHAT: TAMCO SERIES 9000BF THERMALLY BROKEN AND INSULATED BLADE AND FRAME

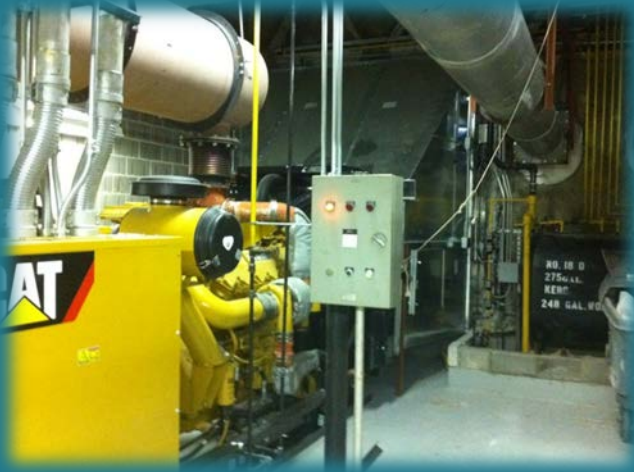
- INSIDE VIEW OF GENERATOR
 - ONLY SMALL ACCESS TO DAMPERS
 - INCREASE NEED FOR MAINTENANCE FREE OPERABILITY

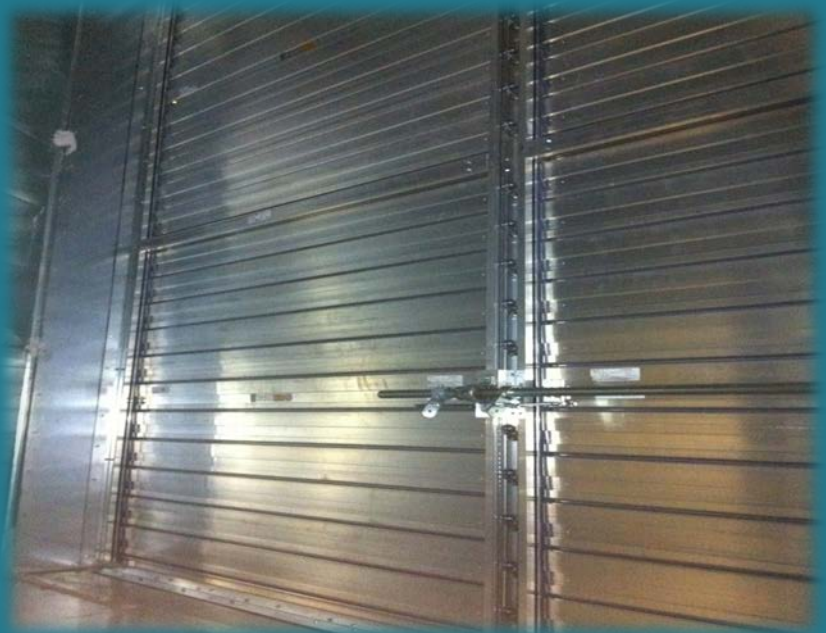
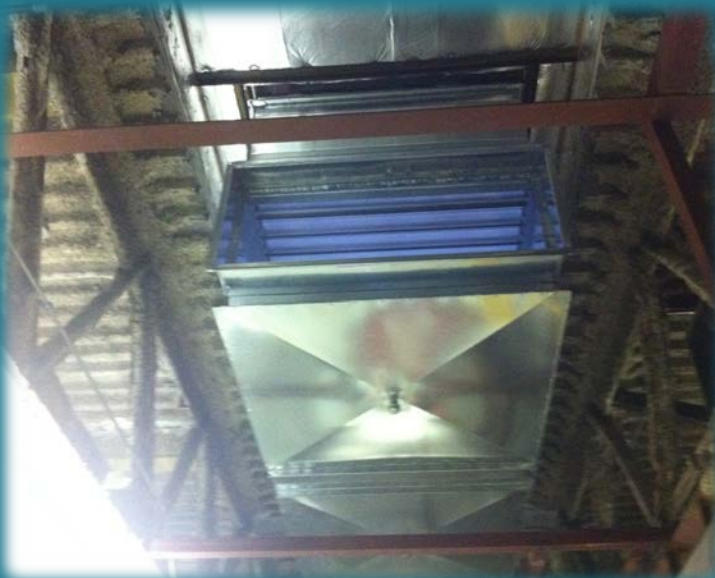
- INSTALLED AT ROOF LEVEL
- FULLY EXTRUDED ALUMINUM BLADE AND FRAME
- MOUNTED IN DUCT
